IDENTIFICATION OF FUNGUS IN THE FIELD AND RECOMMENDATIONS FOR ITS REMOVAL

TECHNICAL BULLETIN TB-27

Rev 3, November 2003

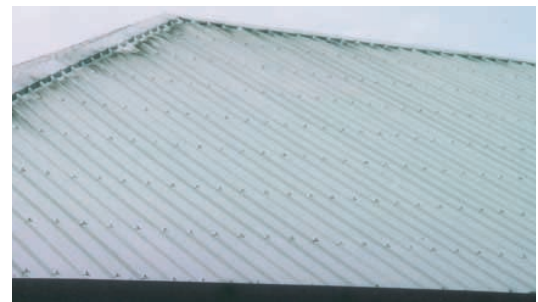
It is not uncommon to have heavy areas of fungal infestation on a building. A typical portion of a roof where this type of effect is observed is around the ridge-capping, as shown in Figure 2.

It is believed that this “ridge-cap” effect is due to the favourable micro-environment for fungal growth which exists in this area because of moisture and/or nutrients leaving the roof cavity at the junction of the ridge capping and the roofing sheets.

Figure 2: Photograph of a roof made from COLORBOND® steel showing fungal growth in the vicinity of the ridge-capping.

hypochlorite solution. The sodium hypochlorite solution can be made up from commercially available bleaches. To assist in making up the solution, Table 1 below shows the dilution required for different strength bleaches to give a 2% solution. The bleach should be applied with a soft bristle broom, left for 3-5 minutes, and then washed off with copious amounts of water. A small amount of non-ionic detergent may be added to the bleach if necessary to improve wetting.

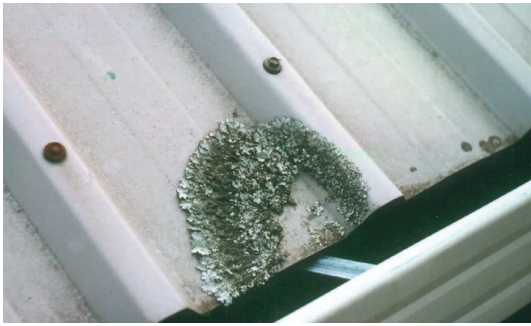
Lichen is a growth which incorporates both fungus and algae. Its appearance, as illustrated in Figure 3, is quite distinctive.

Figure 3: Photograph of lichen on a roof made from COLORBOND® steel.
